The attached report contains the findings of the **Tulalip Quil Ceda wastewater (MBR) system** survey conducted on **October 23, 2012**. The survey was conducted by Karin Knopp(IHS), Jason Schneider (IHS), and Mike Cooney (Tulalip Tribes). Present during the survey were Lukas Reyes (interview portion); and field workers Jeremy and Jaret (plant, pump station, and drainfield tours).

Liquid Waste Survey

Tulalip CSS-Quil Ceda MBR
8802 27th Ave NE
Tulalip, WA 98271
(360) 716-5000

Survey Date: 10/23/2012
Time In: 10:00 AM
Time Out: 3:00 PM
Survey Purpose: Routine

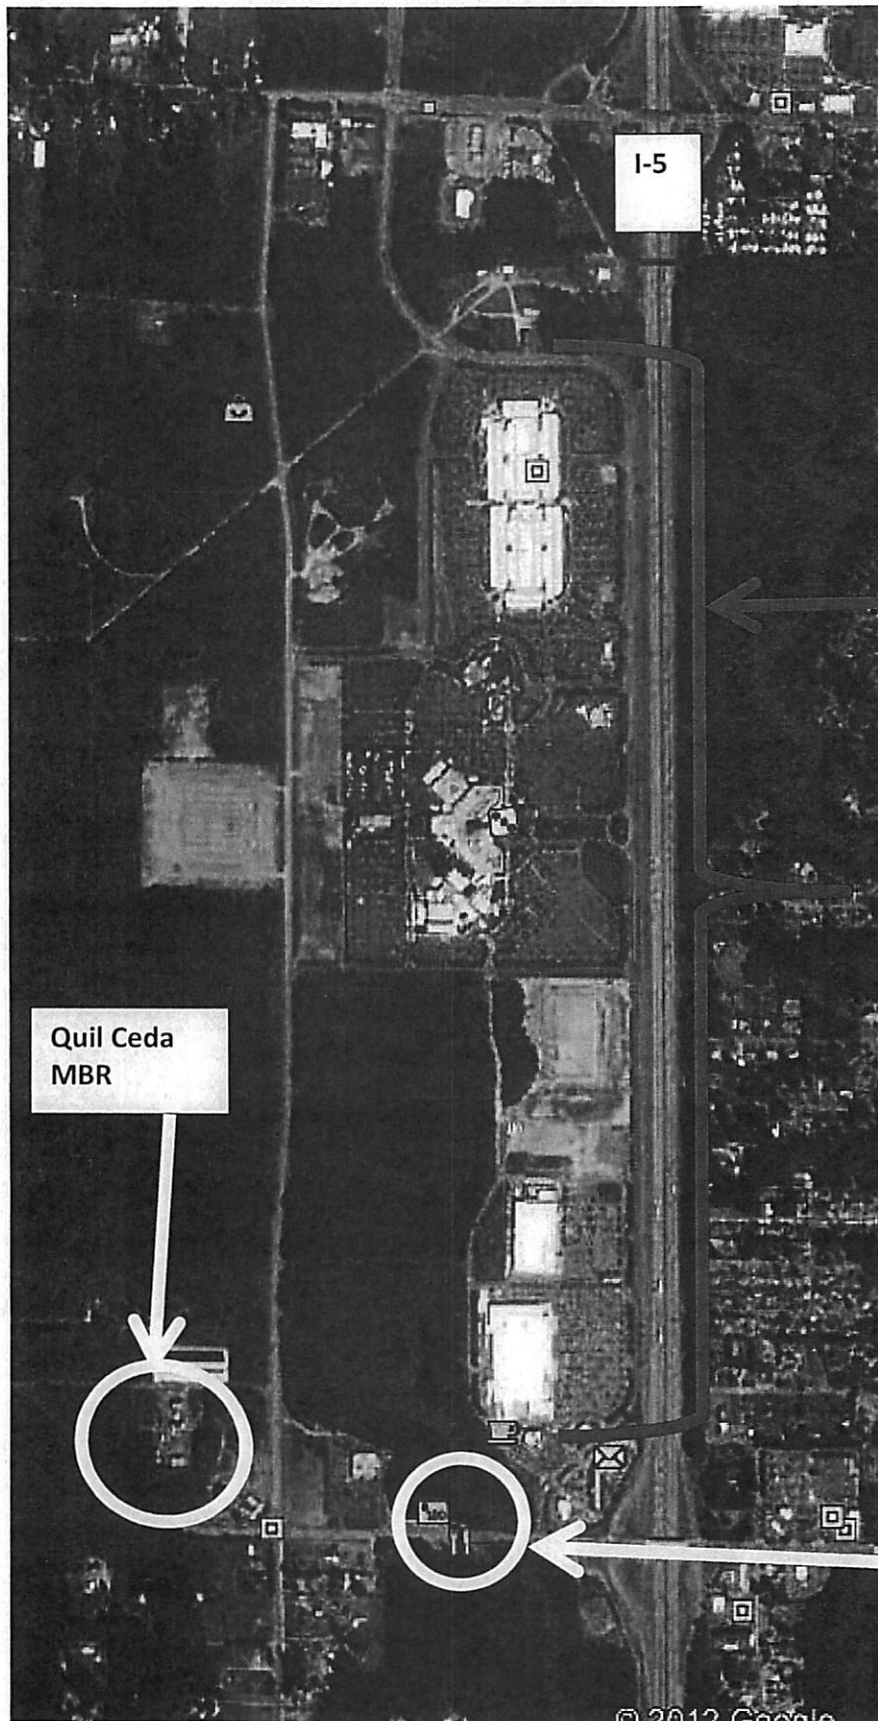
- 1) All Sewage gravity flows to pump station on 88th.
- 2) From 88th, pumped to MBR Plant where it gravity flows through the 3 buildings
- 3) From MBR, pumped down 99th street to the UIC drainfield pipes that parallel Interstate 5.

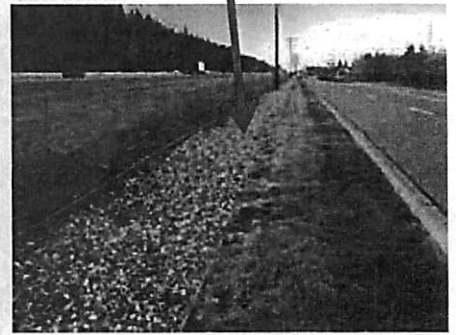
Here is a small portion of the Quil Ceda sewage effluent drainage area.

It comes from the MBR plant and runs along I-5 underneath rocks.

You can see the area as you drive down Quil Ceda Blvd.
